**Grate Drainage Performance Certificate      ID: Square Shower Drain**

**Flow Characteristic Curve – Paige Stainless - Square Shower Drain and Trough**

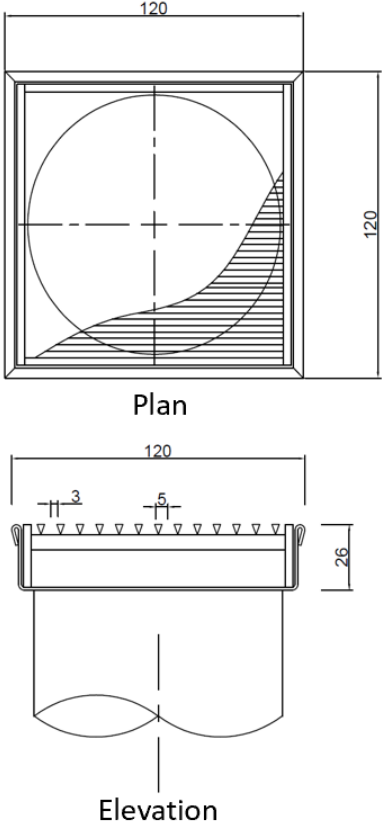
<p><b><u>SQ GRATE AND TROUGH</u></b></p> </div> <div style="text-align: center;">

<p><b><u>SQ TILE INSERT AND TROUGH</u></b></p> </div> </div>	
<b>Test Grate Configuration</b>	<p>The shower grate housing was installed flush with test rig base. Both the grate and tile tray models use the same housing. The grate and tile tray were placed into the housing alternatively and the maximum inflow rates through the slot were measured for different ponding levels (H). These were recorded and are shown on the following page.</p>

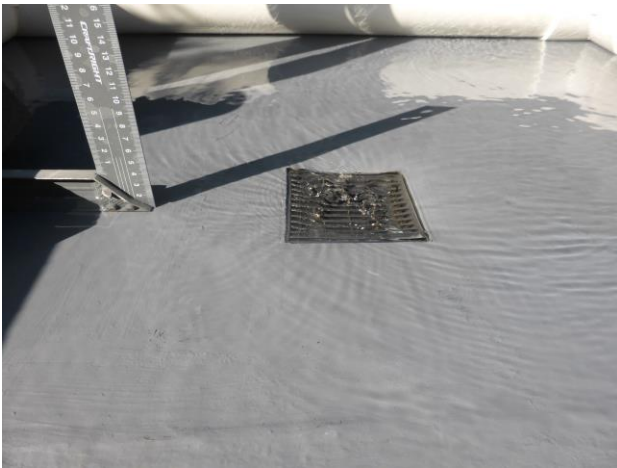
Stainless Grate 1.3 L/s (15 mm)
